QuakeCheck:

*When the big quake comes, will your home be
“Safe Enough to Stay?”*

Find out why inadequate earthquake ‘retrofits’
leave many older homes vulnerable to quakes, and
whether your home may still need strengthening

November, 2012

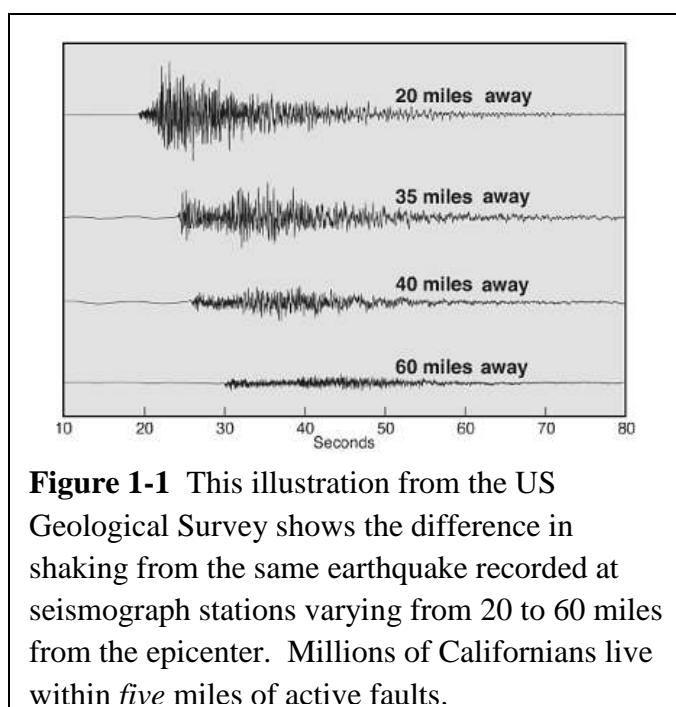
Figure 1-1 This illustration from the US Geological Survey shows the difference in shaking from the same earthquake recorded at seismograph stations varying from 20 to 60 miles from the epicenter. Millions of Californians live within *five* miles of active faults.

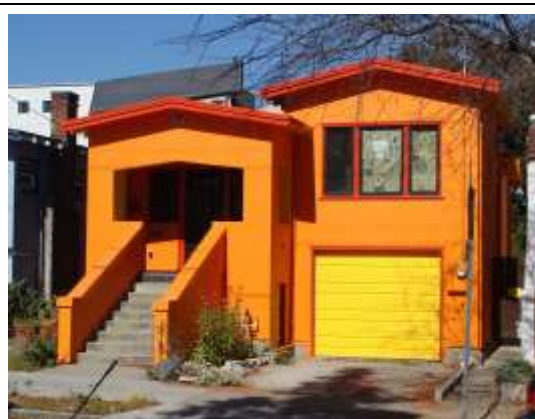
Figure 2-1 Typical house with cripple walls.

Cripple-wall house: **Figure 2-1** shows a wood-framed house supported on a perimeter foundation with a crawl space or basement below the first floor, and cripple walls between the foundation and floor. A majority of homes built before 1950 are in this category and this type of construction is still common. The difficulty and cost of an upgrade is affected by the degree of access below the floor. Where clearance

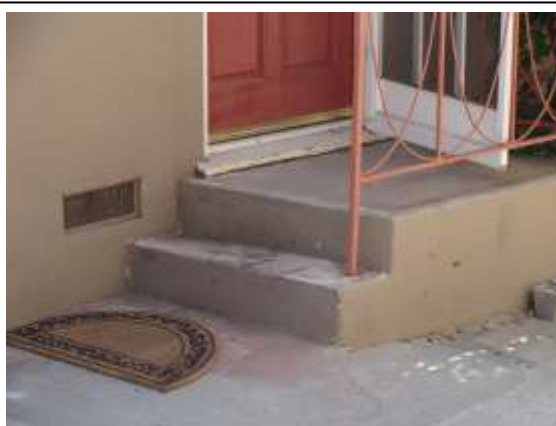
Figure 2-2 Typical house with crawl space and NO cripple walls. If there are foundation vents around your house but it only has one or two steps up to the main floor level, it probably does not have cripple walls.

The photo in **Figure 2-2** shows the entry to a house supported on a perimeter foundation with a crawl space below the first floor, but without cripple walls. In such houses, the floor framing is supported directly on the mudsill. This style became common in the 1940s and is still widely used. As in houses with cripple walls, access to the subarea may significantly affect cost and difficulty.

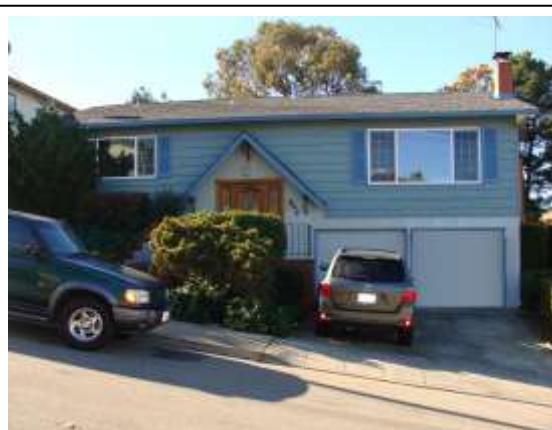
Figure 2-3 Mixed foundation systems. This house has a lower-level garage on the right with full-height wood-framed walls, and a crawlspace on the left with no cripple walls. Other weaknesses include a split-level floor at the entry, and a “weak-story” at the garage. Another hazard is the brick chimney. All of these are special cases beyond the scope of this document.

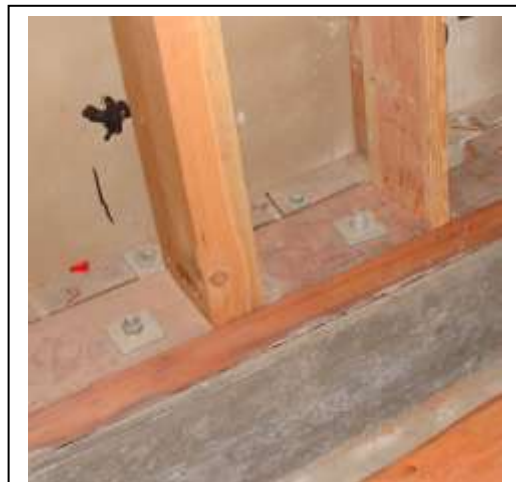
Figure 3-1 Mudsill connection to the foundation in a house under construction. This crucial connection transfers earthquake forces to the foundation.

Anchor bolts in a new foundation. Figure 3-1 shows a wall under construction. Note the large square washers or “bearing plates” on the anchor bolts. These are required by current building codes, and are best practice to use when installing retrofit foundation anchors.

The mudsill is a different color from the other lumber because it is treated with chemicals to resist moisture and structural pests.

The vertical “studs” will support the wall surfaces and the structure above.

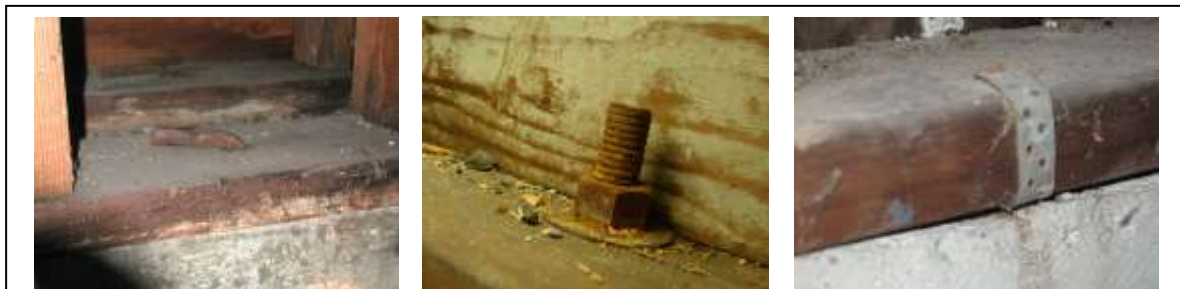
Figure 3-2 Mudsill connections used in the past. From left to right: Steel rod, pin, or bolt bent down over mudsill; bolt with standard round washer and nut; proprietary sheet-metal strap embedded in concrete and wrapped around and nailed to mudsill.

Most Bay Area homes built before the 1940s do not have foundation bolts, which were not required by the building codes of the time. These buildings can readily slide off the foundation in an earthquake. Nearly all homes built from the 1940s through the 1970s have bolts or other anchors. This is an improvement over times when no connections were required at all, but the anchors usually are too small, too far apart, or otherwise inadequate by today’s standards. Homes of this era typically need an upgrade to ensure they are reliably anchored. **Figure 3-2** shows some older types of mudsill connections, described as follows.

Anchor bolt used from about 1950 through about 1995. The bolt shown in **Figure 3-2** is typical of the era when bolts were first widely installed. It is smaller ($\frac{1}{2}$ " diameter) than bolts used in current construction and it lacks the large square washer or "bearing plate" needed to help ensure the mudsill will not split during earthquake loading. Older bolts like this often do not extend far enough into the concrete foundation, and may be partially rusted through.

Proprietary anchors: Various labor-saving products have been used (and some are still available) to avoid having to carefully align bolt holes in mudsills with the corresponding foundation bolts. The narrow metal strap shown above right is an early version of one of these. Even when installed correctly, these sorts of anchors performed badly in recent quakes.

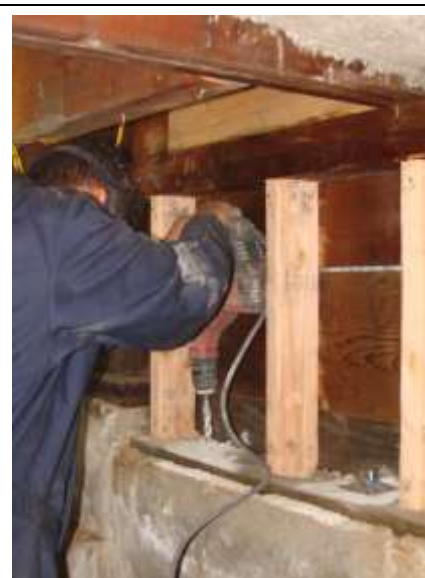
Figure 3-3 Retrofit bolt installation at a cripple wall.

Retrofit Bolts: Where there is enough space above the foundation, bolts can be added by drilling downward through the mudsill and into the concrete, as shown in **Figure 3-3**. The heavy-duty drills used in retrofit work need about two feet of clearance in order to drill straight down into the foundation.

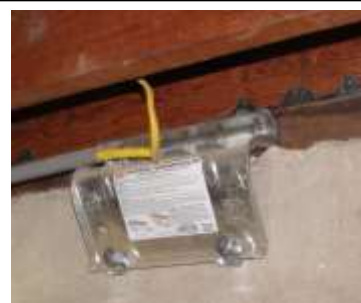
Figure 3-4 A Simpson “UFP10” used where bolt holes could not be drilled from above (yellow electrical cable and gray conduit to left are not related to the connector).

Mudsill connectors for low-clearance installation: Where there is not enough room for drilling from above, standard bolts will not work. Several types of connectors are available that can be secured to the side of the foundation with bolts into the concrete and structural screws into the edge of the mudsill. **Figure 3-4** shows a “Universal foundation Plate” (UFP10) manufactured by Simpson Strong-Tie Company. This hardware is specifically engineered for this situation, and has undergone testing to establish its load capacity.

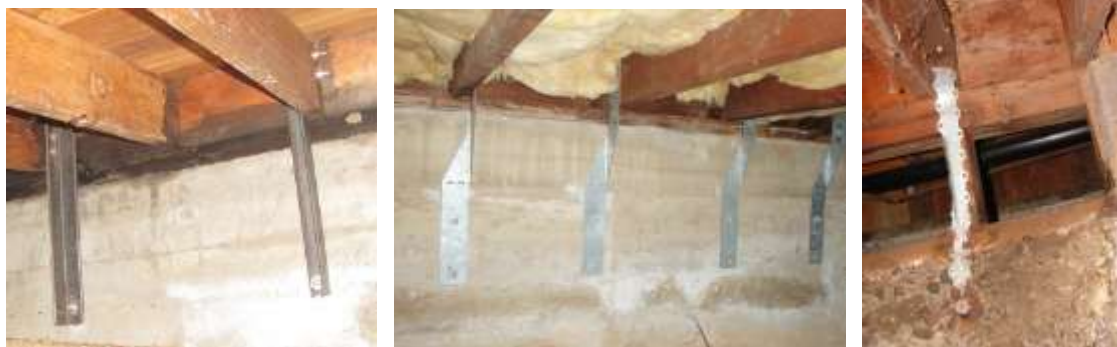
Figure 3-5 The steel angles, “hurricane ties” and flat steel straps shown are not appropriate connectors to resist earthquake forces.

“Hurricane ties:” Sheet metal anchors as shown in the middle below are designed for resisting upward loads; they have very little resistance to the side-to-side forces of an earthquake. Unfortunately, they are fairly common, especially in retrofits from the 1990s, before more appropriate hardware was widely available. The best approach is usually to leave these in place and install anchors designed for the situation, such as the UFPs shown above.

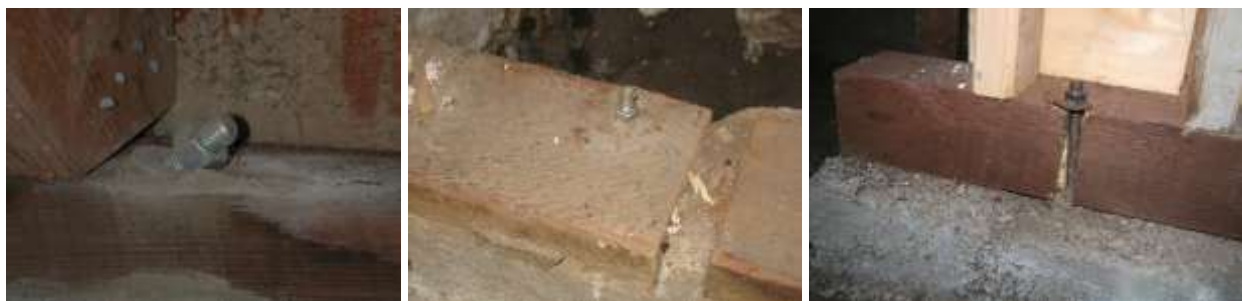
Figure 3-6 These photos show several examples of bad anchor bolt installations:
Left: Retrofit bolt installed at an angle; Center: Bolt that is too small, installed without a proper washer and too close to the end of the mudsill; Right: Mudsill slotted to install in the course of repairing decay or pest damage.

Faulty pest repair work: The section of mudsill shown below right was installed as a repair on a foundation where bolts were already present. Since the house could not be lifted to permit dropping the new mudsill over the bolts, the installers cut slots into the sill so they could slide it in sideways. The slot substantially weakens the mudsill. Also, the bolt is probably not embedded deeply enough in the concrete, and it lacks an adequate washer. This installation would not meet any code, whether it is supposed to resist earthquake forces or not.

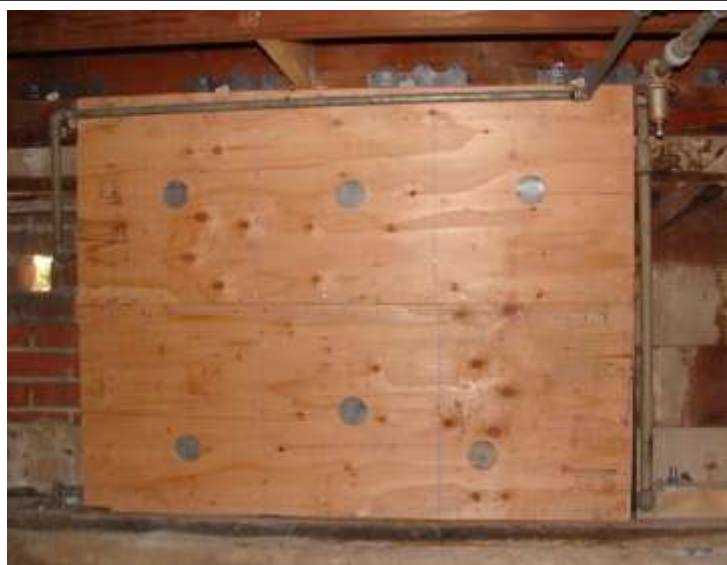
Figure 3-7 Plywood bracing panels nailed along all edges. Note the horizontal joint with nailing above and below the joint. The six holes provide ventilation to help prevent moisture build-up and associated damage

A properly installed plywood bracing panel must be securely nailed to solid framing at all edges, as shown in **Figure 3-7**. Any seams in the panel—such as the horizontal one here—must have framing installed behind them so that all panel edges can be securely nailed. (Plywood comes in 4-foot widths, but you may have to cut narrower strips in order to fit them into the work area.)

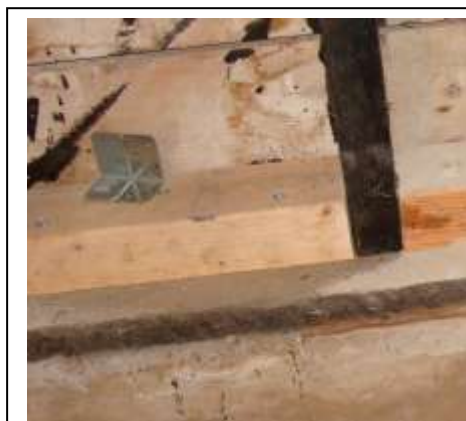
Figure 3-8 Mudsill blocks connected with structural screws.

Screw connections: The block shown in Figure 3-8 is connected to the mudsill with special screws. This provides a solid connection that also keeps the block from lifting off the mudsill. (Lifting results from the bracing panel rocking back and forth, not from vertical earthquake forces.)

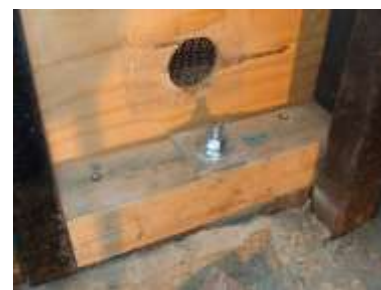
Figure 3-9 Mudsill block with proper attachment to foundation and mudsill. TM-RDW

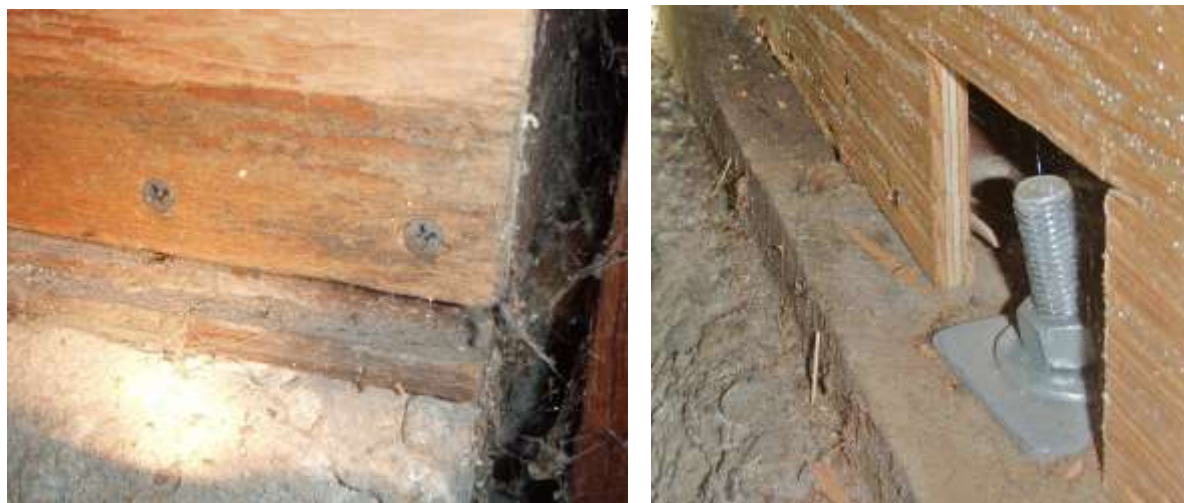
Figure 3-10 Defective plywood connections: Left—drywall screws; Right—toe-nails along bottom edge of plywood into the mudsill. TM-RDW, Mar C

Nails too close to plywood edges: Nails must be installed at least 3/8" away from the panel edges, and preferably further. Nails that are too close to the edges can tear out of the plywood during an earthquake. In the right-hand photo in Figure 3-10, the bottom edge of the plywood is "toe-nailed" to the mudsill, which is an especially poor connection.

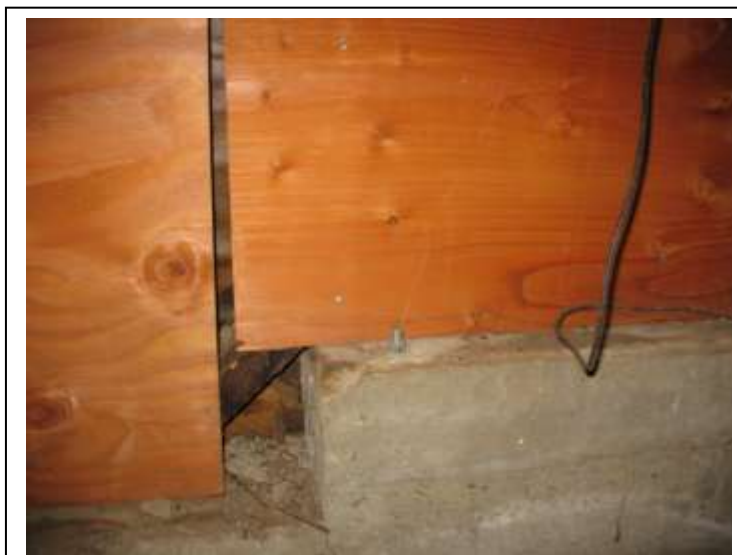
Figure 3-11 Plywood must be nailed to framing along each panel edge. TM—Max CamoW

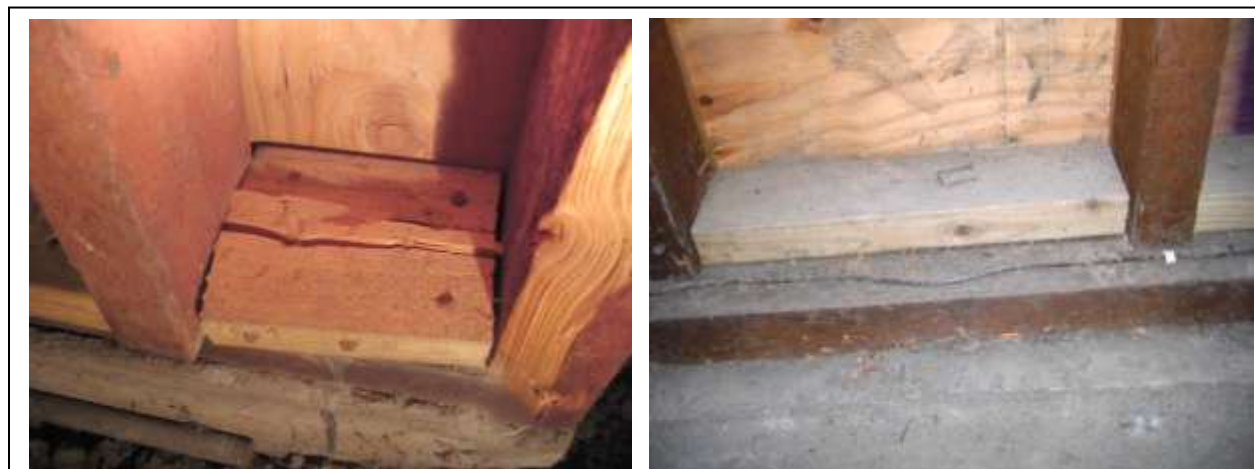
Figure 3-12 Mudsill block problems: Left—Split block; Right—lack of visible connection from block to mudsill. TM—Paul Rude

Lack of secure block connection: In the right-hand photo in **Figure 3-12** no nails are visible in the block, indicating that it is not properly attached to the mudsill. Nails may have been driven into the ends of the block through the studs, but such a connection is much weaker than nailing directly to the mudsill.

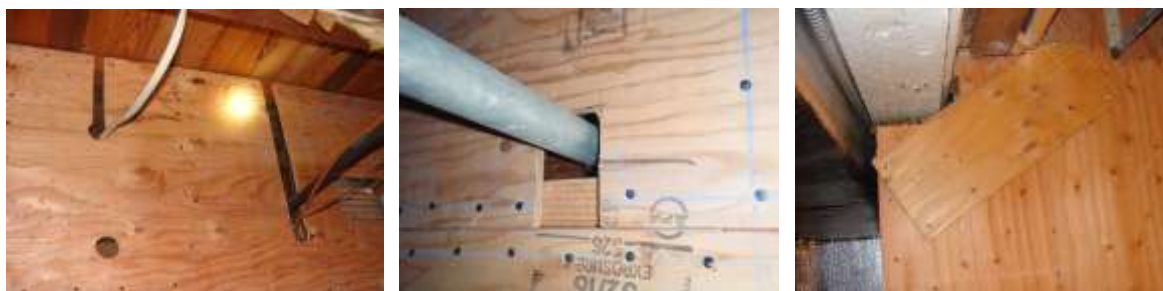
Figure 3-13 Slots severely weaken plywood bracing panels. If existing utilities cannot be avoided, slot length should be minimized (center) or a plywood patch glued to the plywood to reinforce it. The right-hand photo shows a diagonal patch that was installed to reinforce the notch at the upper-left corner of the plywood panel. © Paul R. & Thor M.

Repairing notches or slots: In a perfect world, nothing would obstruct the plywood installation. In reality, avoiding obstructions is often impractical or adds great expense to the work. Slotted shear panels can be strengthened by gluing plywood patches over the slots, as shown in the right-hand photo in **Figure 3-13**. (Plywood is manufactured by gluing wood veneer together; it can be patched the same way.) The screws in the photo are only there to hold the repair patch in place until the glue dries. Repairs require proper plywood and adhesives.

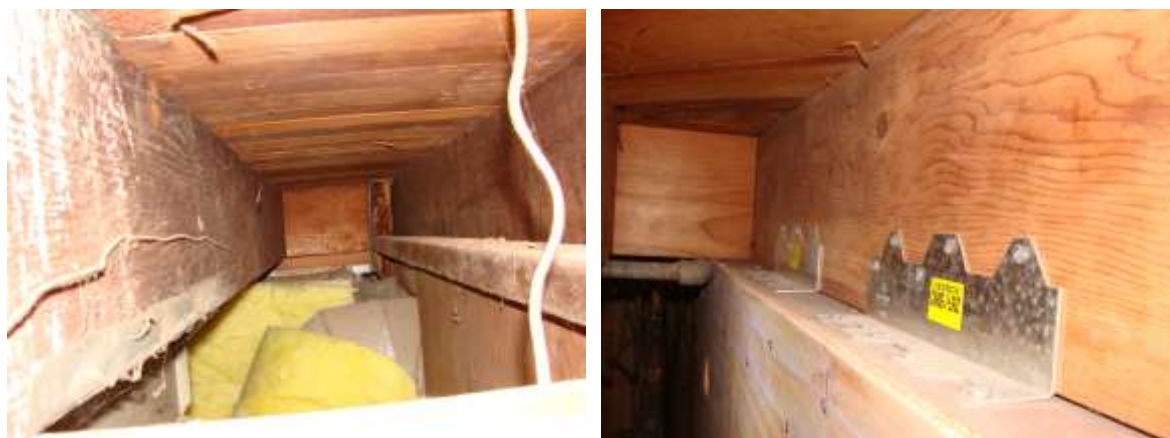
Figure 3-14 Connections from floor framing to the braced walls.

Floor framing connections to braced walls: The floor joist at the right side of the photos below (resting on top of the cripple-wall top plate) was typically only connected with a few “toenails” which provide very little strength to keep it from sliding along the top of the braced wall. The photos in Figure 3-14 show joists before and after proper connections were made. Special tools are almost always needed to drive nails in such restricted areas.

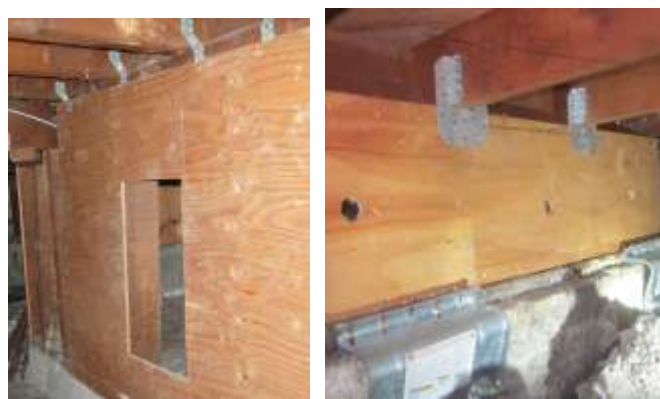
Figure 3-15 “Hurricane Ties” used to connect floor framing. The connectors in the left-hand photo have almost no capacity to resist side-to-side earthquake forces. The connectors in the right-hand photo have a much greater load rating.

The connectors at the top of the wall in the right-hand photo are also “hurricane ties”, but they connect to both sides of the joist and have a much higher rating for side-to-side forces. When this sort of connector is used, blocking between the joists is essential.

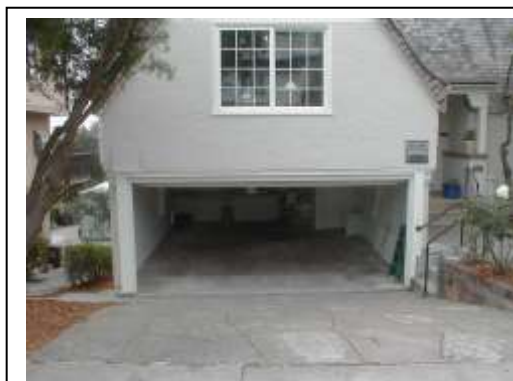
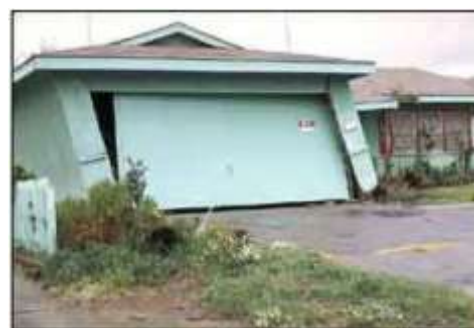
Figure 4-1 Typical “SWOF” construction (top photo) and damage.

The bottom photo shows severe earthquake damage. The added weight of a second floor above would almost certainly have caused complete collapse.

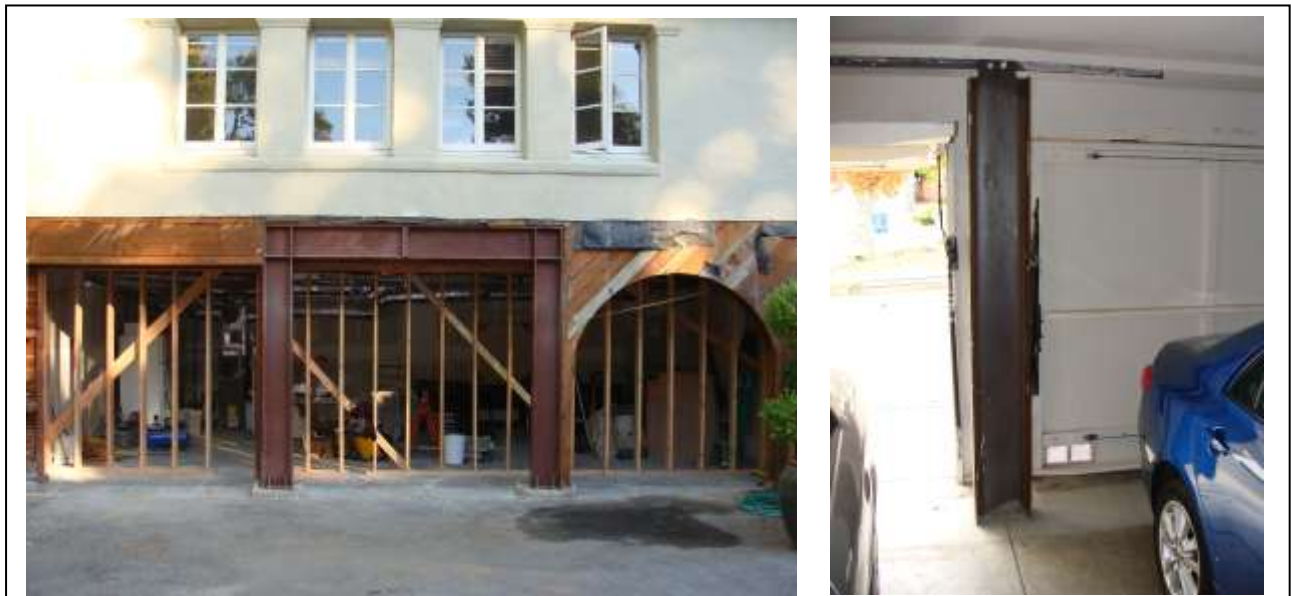
Figure 4-2 Two ways to strengthen a soft-story.

Installation costs for both systems depend on the height of the opening, weight of structure above, the orientation of the floor framing members above the garage, existing obstructions, and other factors. Strengthening a soft-story is an expensive solution using the methods currently available. One of the authors of this document is pursuing a method that would allow lighter-weight moment columns, with related reduction in foundation size.

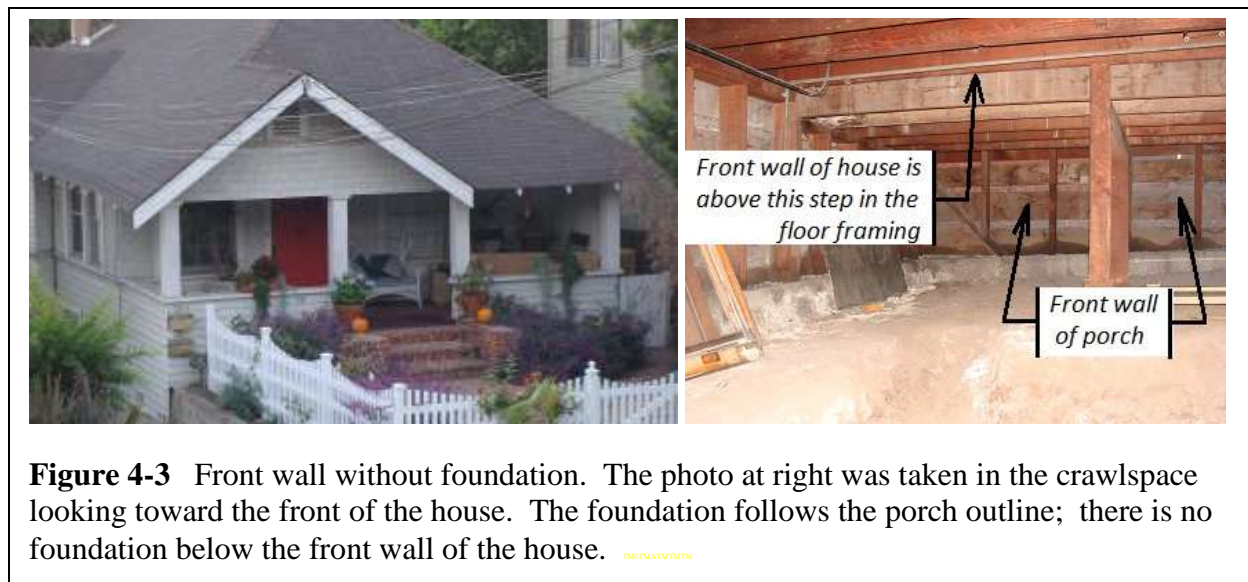
Many older homes with large porches do not have a foundation below the front wall, where anchors and bracing are needed to resist earthquakes. Instead, the foundation follows the outline of the porch. This is especially common in homes built in the 1920s or earlier. In these situations it may be necessary to install a new section of foundation to ensure adequate earthquake resistance. **Figure 4-3** shows exterior and crawlspace views of such a house.

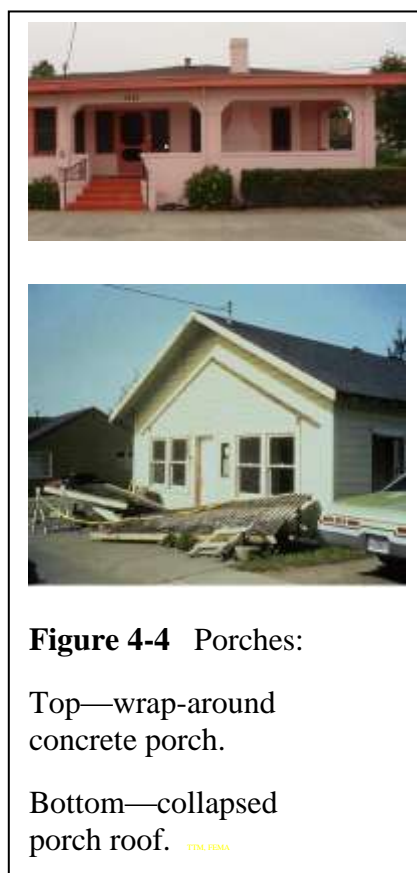
The porch roof in the bottom photo of **Figure 4-4** shook back and forth and collapsed when it tore away from the house. Porch roofs that are not at least partly contiguous with the main roof of the house are most susceptible to collapse (note the porch roof outline left on the front wall in the photo—the roof had only been “planted” on to the front wall). Heavy roof construction (tile or slate, or several layers of old roofing) also increase the hazard.

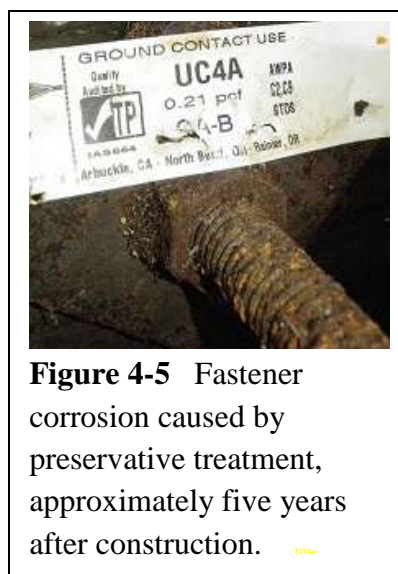
Figure 4-5 Fastener corrosion caused by preservative treatment, approximately five years after construction.

Corrosion can cause structural connections to fail. In the case of bolts or other anchors, failure could allow the structure to slide off the foundation in an earthquake. Corrosion of nails in shear panels or exterior sheathing could result in total failure of wall bracing. The severity of the problem varies with the specific formulation, the type of hardware installed, moisture conditions, and other factors. Because this is a relatively recent development, the potential for failure is still uncertain—but based on reports from contractors and field observations, the outlook is not good. Anchors and nails are usually concealed in a completed building, so it can be difficult to evaluate the extent of damage.

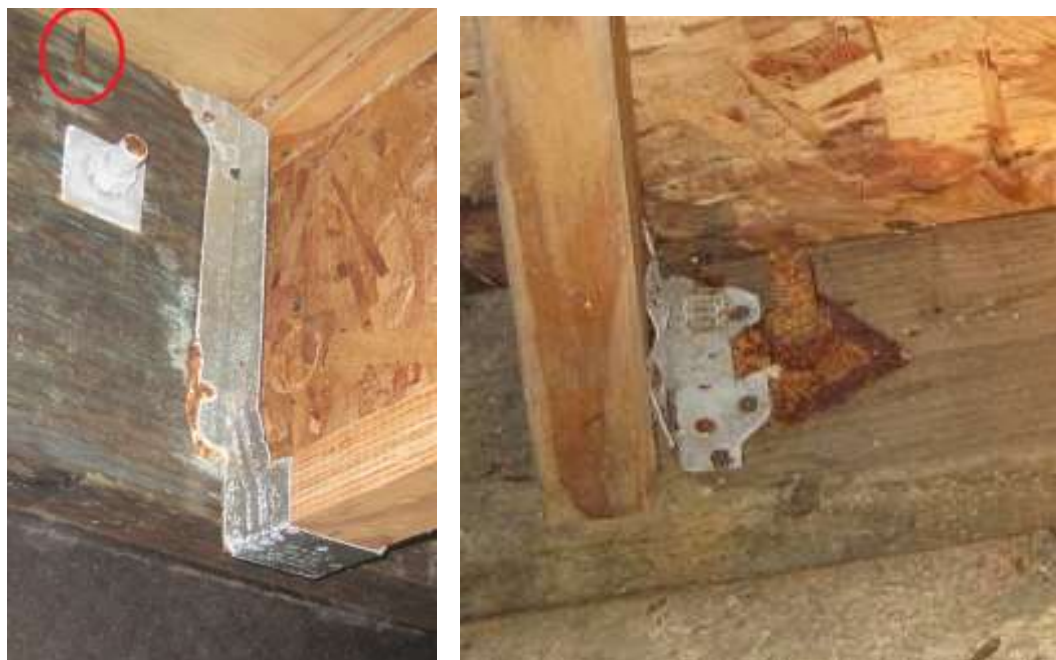
Figure 4-6 Corroding steel and galvanized steel connectors.

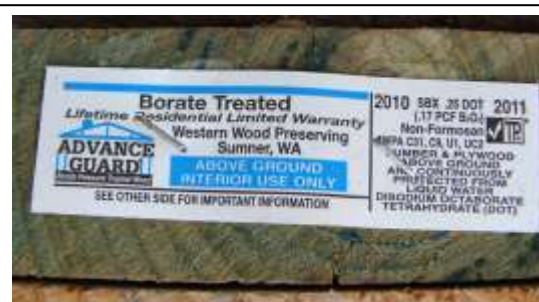
Figure 4-7 Borate treated lumber is not toxic to humans, and does not increase corrosion in fasteners like other chemicals.

RECOMMENDATIONS: There are two simple solutions to the corrosion problem. The first is to use stainless steel framing connectors; these are *very* expensive. The better alternative is to use **BORATE TREATED** lumber. Borate treatments are not waterproof, and must not be used for decks, fenceposts, or other members exposed to liquid water—but borate-treated lumber is appropriate for mudsills and other members that are protected from weather.

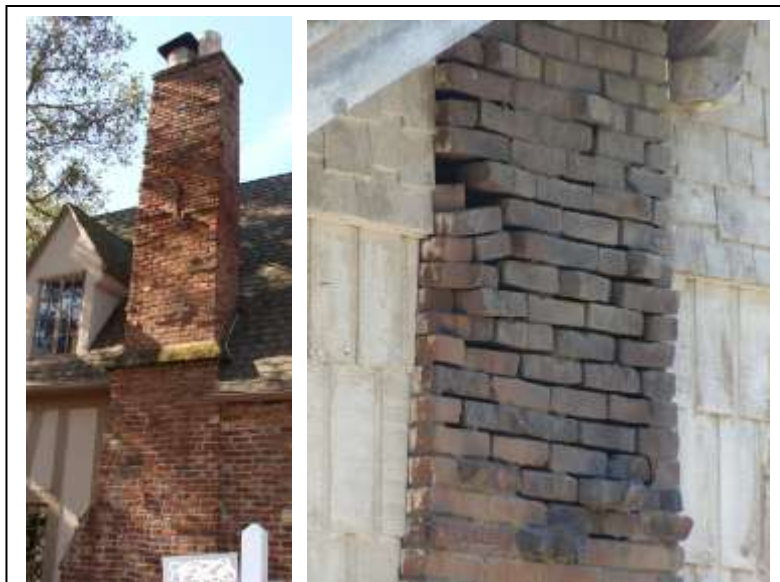
Figure 4-8 Chimneys are hazardous even when they are in good condition. Slamming the front door could cause the disintegrating chimney shown at right to collapse.

Masonry chimneys are very vulnerable to earthquakes; collapse can result in death or serious injury. **Figure 4-8** shows two dangerous chimneys. The safest approach is to have chimneys removed, at least down to the level of the mantle. Where a fireplace must be retained, a metal flue can be installed. Steel braces may reduce the hazard, but most existing braces are inadequate. Bracing that meets current codes is *extremely* expensive to design and install; even braced chimneys may shed individual bricks in a strong quake.

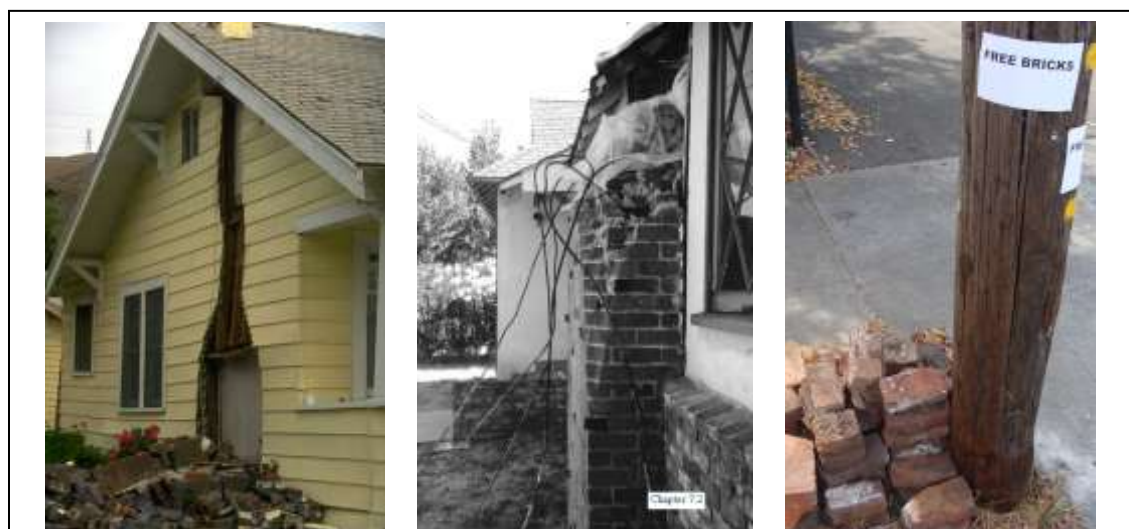
Figure 4-9 Collapsed chimneys; in the left-hand photo notice the bricks that remain at the roof level, ready to fall in an aftershock. Right-hand photo shows a good way to dispose of your chimney before an earthquake can knock it over!

One measure of earthquake intensity is whether or not chimneys collapse. The 1994 Northridge Earthquake knocked over the chimney shown in the left photo in **Figure 4-9**. The center photo shows a chimney that was built to recent code (note the twisted reinforcing steel), yet still fell over—as did tens of thousands of similar chimneys in the Northridge Earthquake (and others).

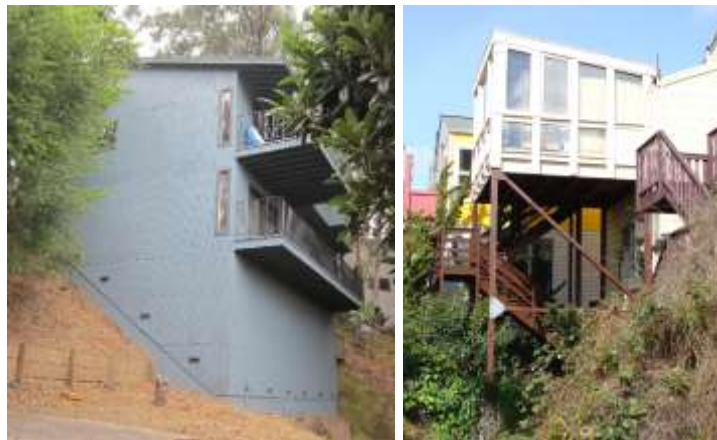
Figure 5-1 Hillside homes require special consideration; plywood shear walls perform badly in sloping walls as found in the house shown above left. Homes on steep sites can be very dangerous in quakes.

Figure 5-1 shows two typical hillside homes, one supported by a perimeter foundation and another supported on tall posts. Both of these homes need special bracing measures. Plywood bracing does not work well on sloped or stepped foundations, even if it is installed following the recommendations given earlier.

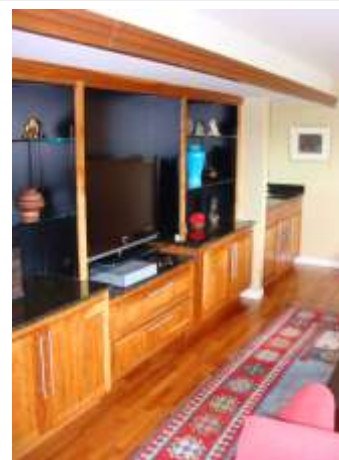
Figure 5-2 Installing earthquake strengthening measures will help protect your basement remodel, as well as the rest of your house.

The newly remodeled basement shown in **Figure 5-2** has lovely cabinets and finishes—but is there plywood behind the freshly-painted walls? Were any mudsill anchors installed? What design guidelines, if any, were followed in designing the retrofit strengthening work?
